# U20 Chip Installation

This article will walk you through the steps to replace a bad U20 chip in the PhysioMonitor.

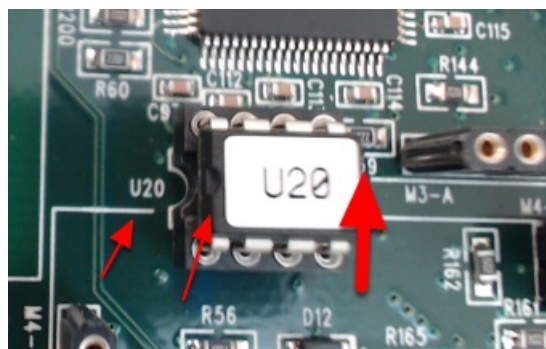
## 7. Install new U20 chip

Line up the new chip and gently press it into place, being careful not to bend the pins.

*Make sure that the chip is in the correct way.* When looking down at the PhysioMonitor the U20 label on the chip should be right side up. If there is no label for whatever reason, know that the small divot on the left side of the chip should be on the same side as the "U20" on the board.
